Repairhints

Communicator 9000/9000i RAE/K-1/4

The purpose of this document is to provide some further service information for NOKIA Communicator 9000/I. It contains a lot of collected tips and hints to find failures and repair solutions easily.

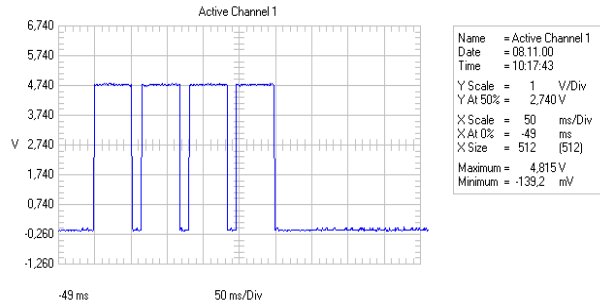
VSIM after switching on the phone without SIMcard. E 400 pulses up VSIM four times to an amplitude of 5 Volt.

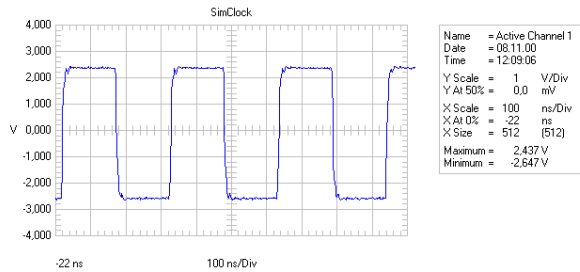
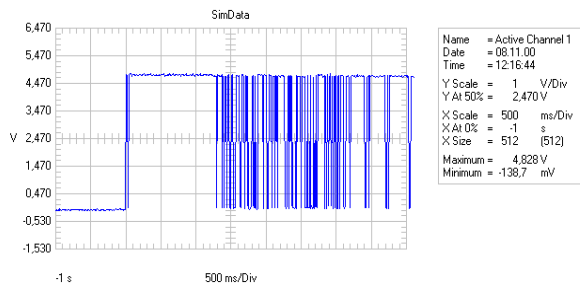
Note that SIMClock and SIMData are only present when SIMcard is active, for example when phone registers to network. Some SIMcards do not allow to switch off SIMClock but the clock-frequency can be reduced from 3.25MHz to 1.625MHz if SIMcard is not used.

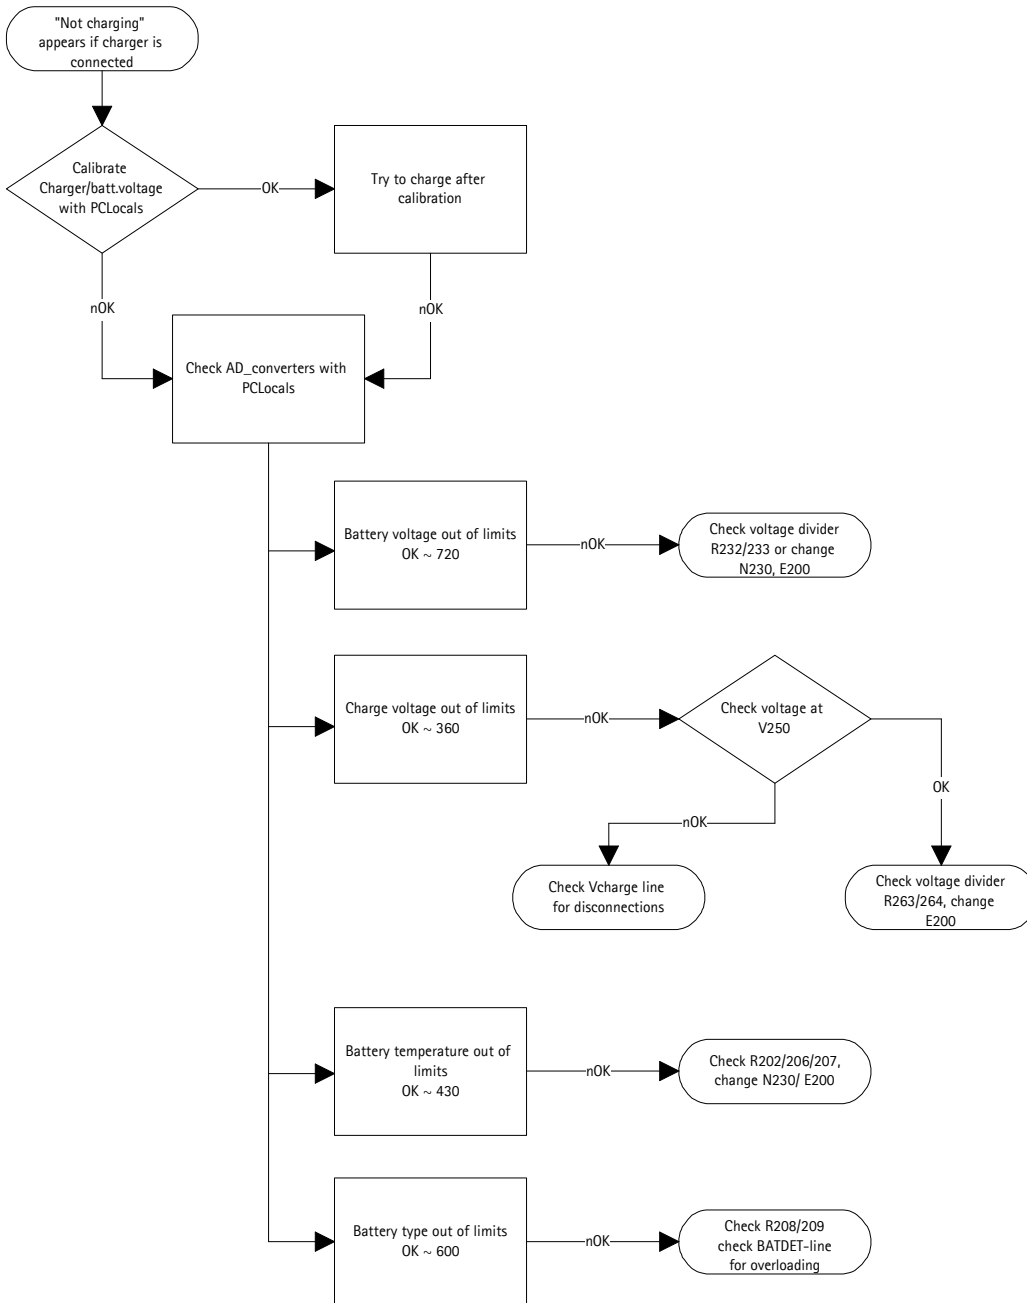
NOT CHARGING

First check X121 and PAR-1 if soiled or oxidized.
Check Vcharge-line for disconnections. Charger-voltage is supplied via connector X121, over L970 / V970 (overvoltage-protection, located on PDA-board) to board-to-board connector X102/201 and from there to V250/251, which are responsible for the fault in most cases.
If charger-voltage is ok at V250 or fault persists after changing V250/251, check CHRDET at E400 Pin 97 (~ 4V DC when charging active).

If charging is possible when communicator is switched on but charger is not recognized in off-state mode, check voltage at N230 pin 11, which is normally 1.7V DC. The only function of CHRDETI line is to get phone from off-state mode into acting-dead mode (phone is powered up but to the user it seems that phone is still switched off, only the battery indicator is scrolling). If there is a disconnection in CHRDETI-line, above mentioned fault will appear.

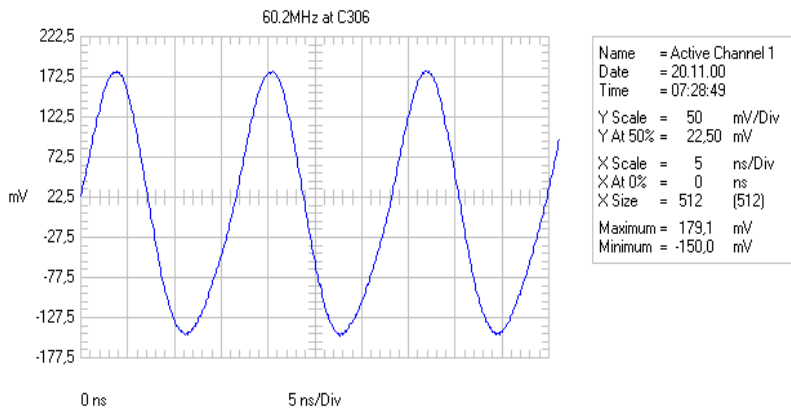
In case of Selftest failures which appears from time to time check DSP-oscillator. It is enabled by ASIC (Check E400 pin 88, 4.8V DC).
Critical parts are the crystal G300, coil L300 and transformer T300. If it is necessary to change the crystal, take care not to destroy L300, which is thermal sensitive!

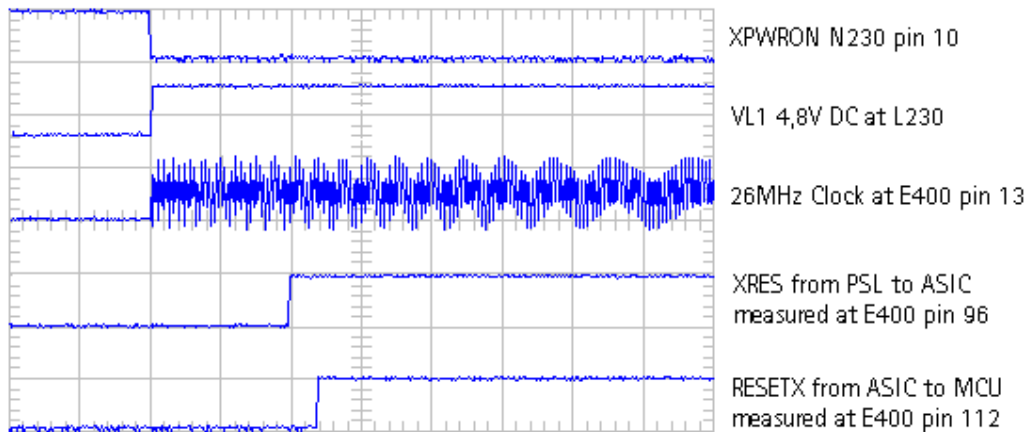
Voltages in the moment of switching on the CMT-part

It is also not possible to switch on CMT of an assembled communicator with an open lid; you can check state of lid with PCLocals under CMT Testings and Adjustments/Logic Controls/Read AD Converters in local mode: Cover information with open lid ~ 870, closed ~ 100.

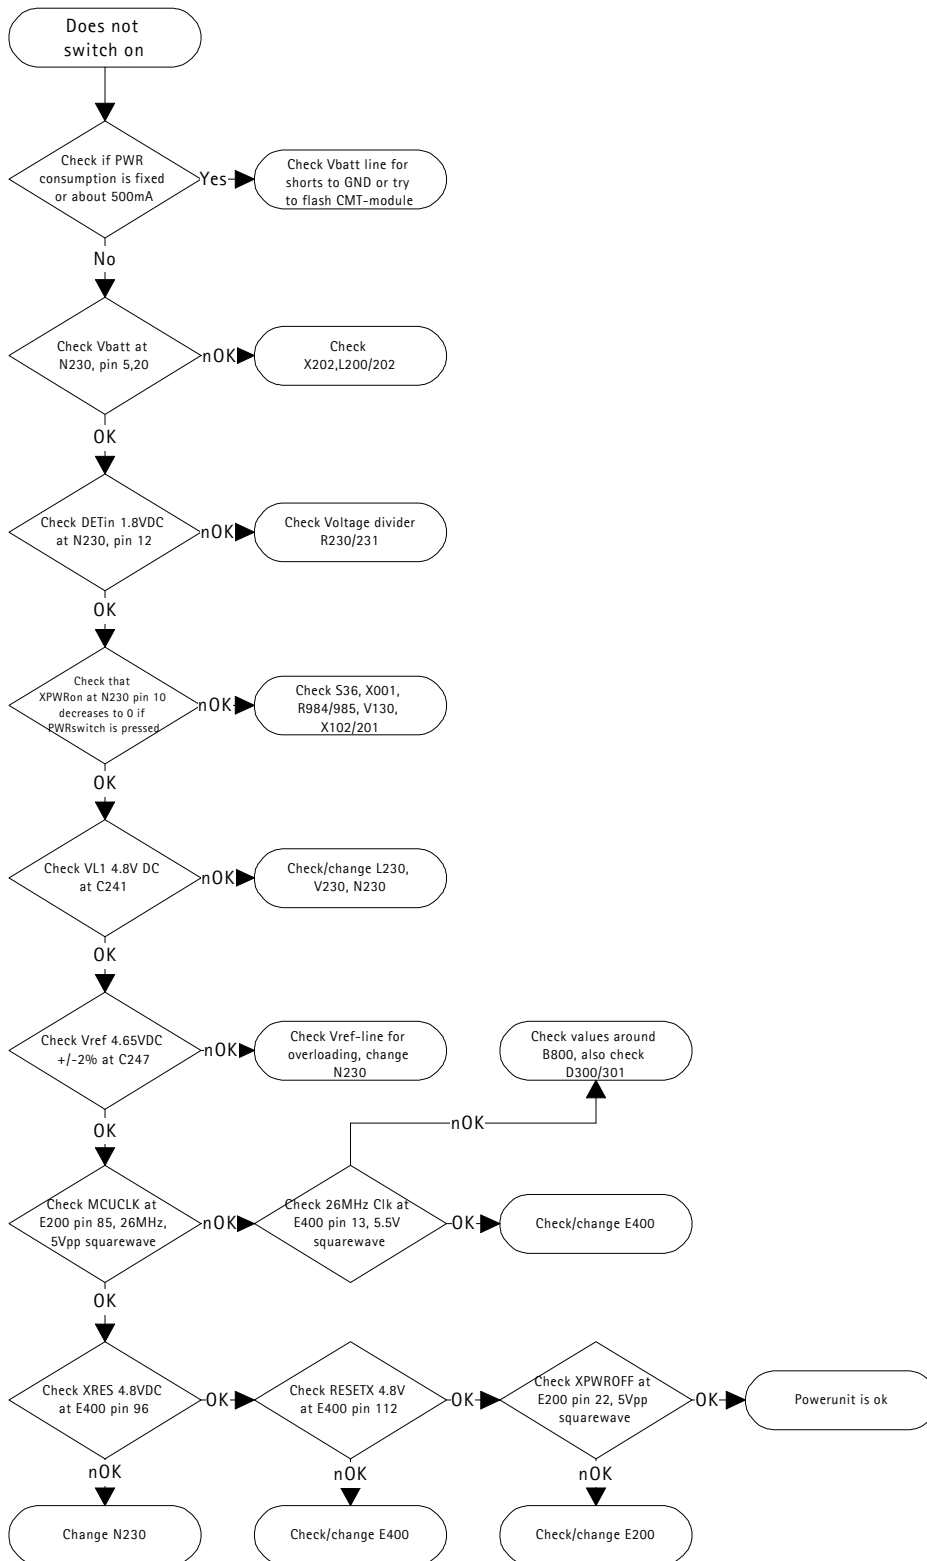
CMT DOES NOT SWITCH ON

In this case check first of all the fault with the normal battery, do NOT connect a service-battery to the phone. If the CMT-module does not switch on disassemble it and check resistance of capacitors C763 and C790-793. If resistance of every capacitor is ok, you can connect phone to a service-battery to check current consumption – the use of other tools may result in burnt traces !

If CMT does not switch on, it can also be necessary to update the CMT software. Because of two different CMT-modules GE-8/GE-9 you have to check out the MCU internal software version. This is necessary to update the different versions with the matching version of CMT-software, for example MCU int. SW 2.16 with ext. SW GE8_216.502 and MCU int. SW 2.17 with ext. SW GE8_217.502. If there is no possibility to read out MCU int. SW, try to flash several times with the different versions. How to carry out the upgrade procedure of the CMT side SW see also SB-005. Note that it is necessary to retune RSSI if CMT-SW has been upgraded to version GE8_216.502 / GE8_217.502.

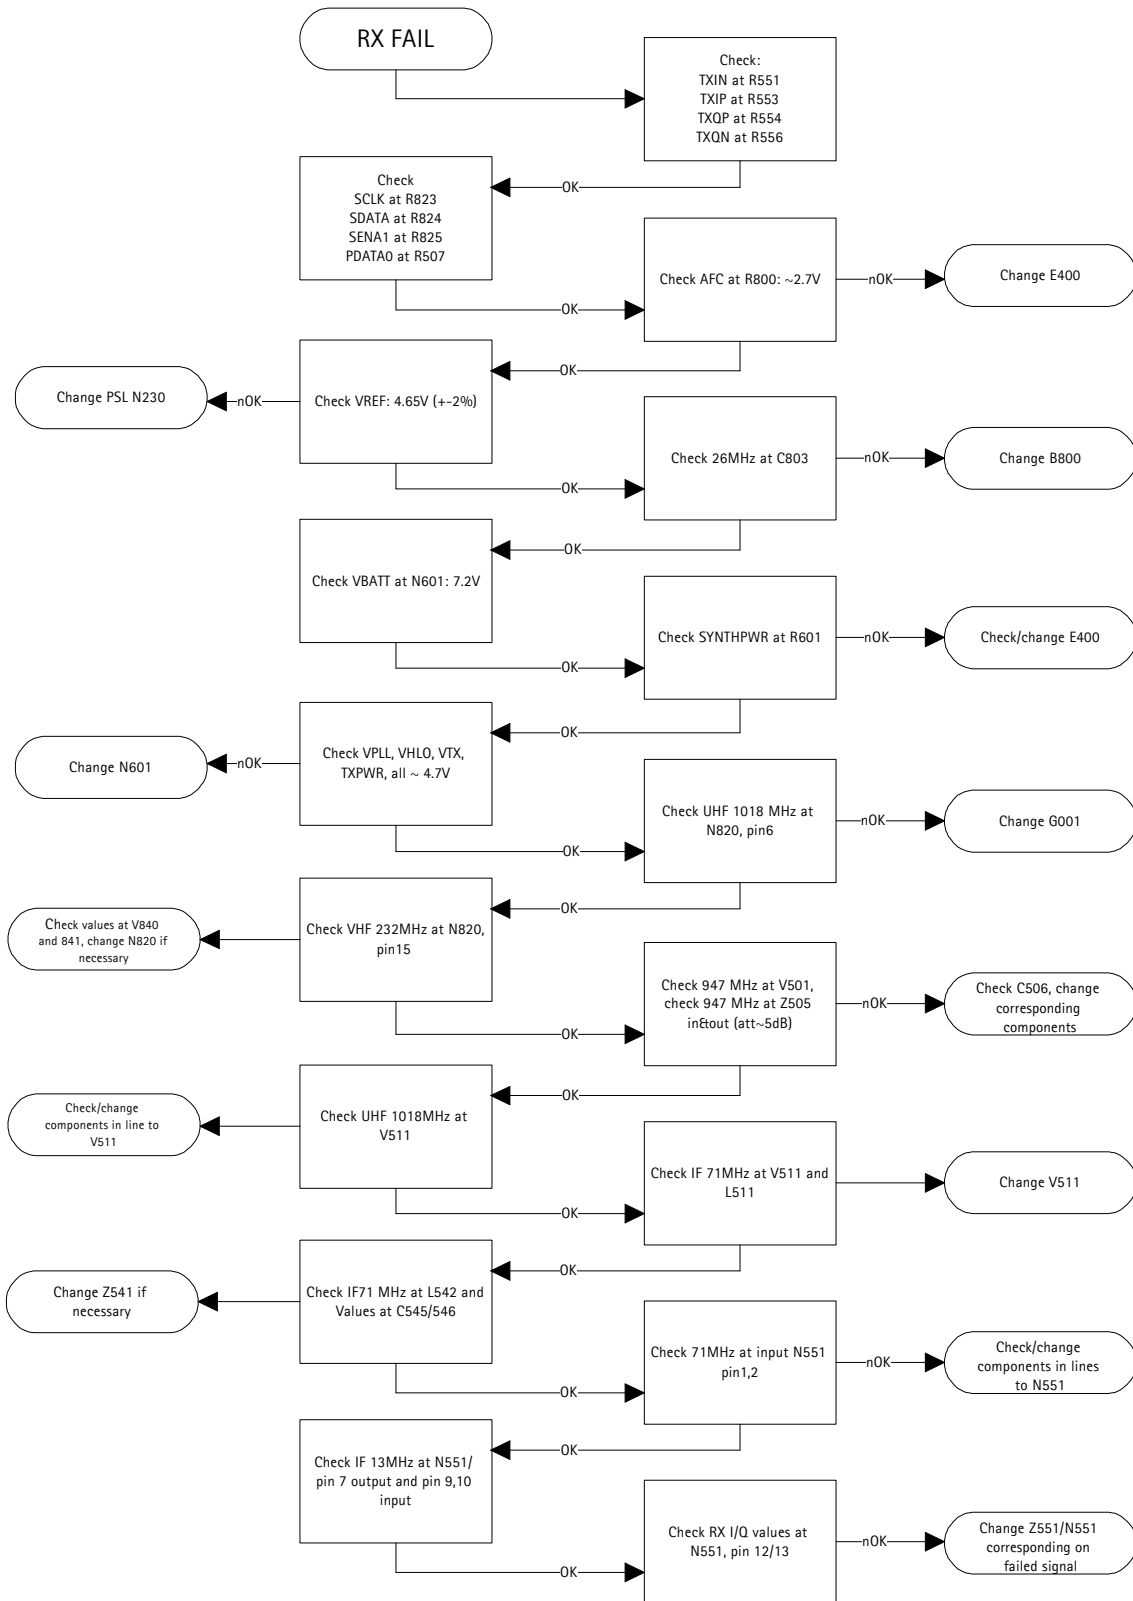
RAE-1

POOR OR NO SERVICE (RAE-1)

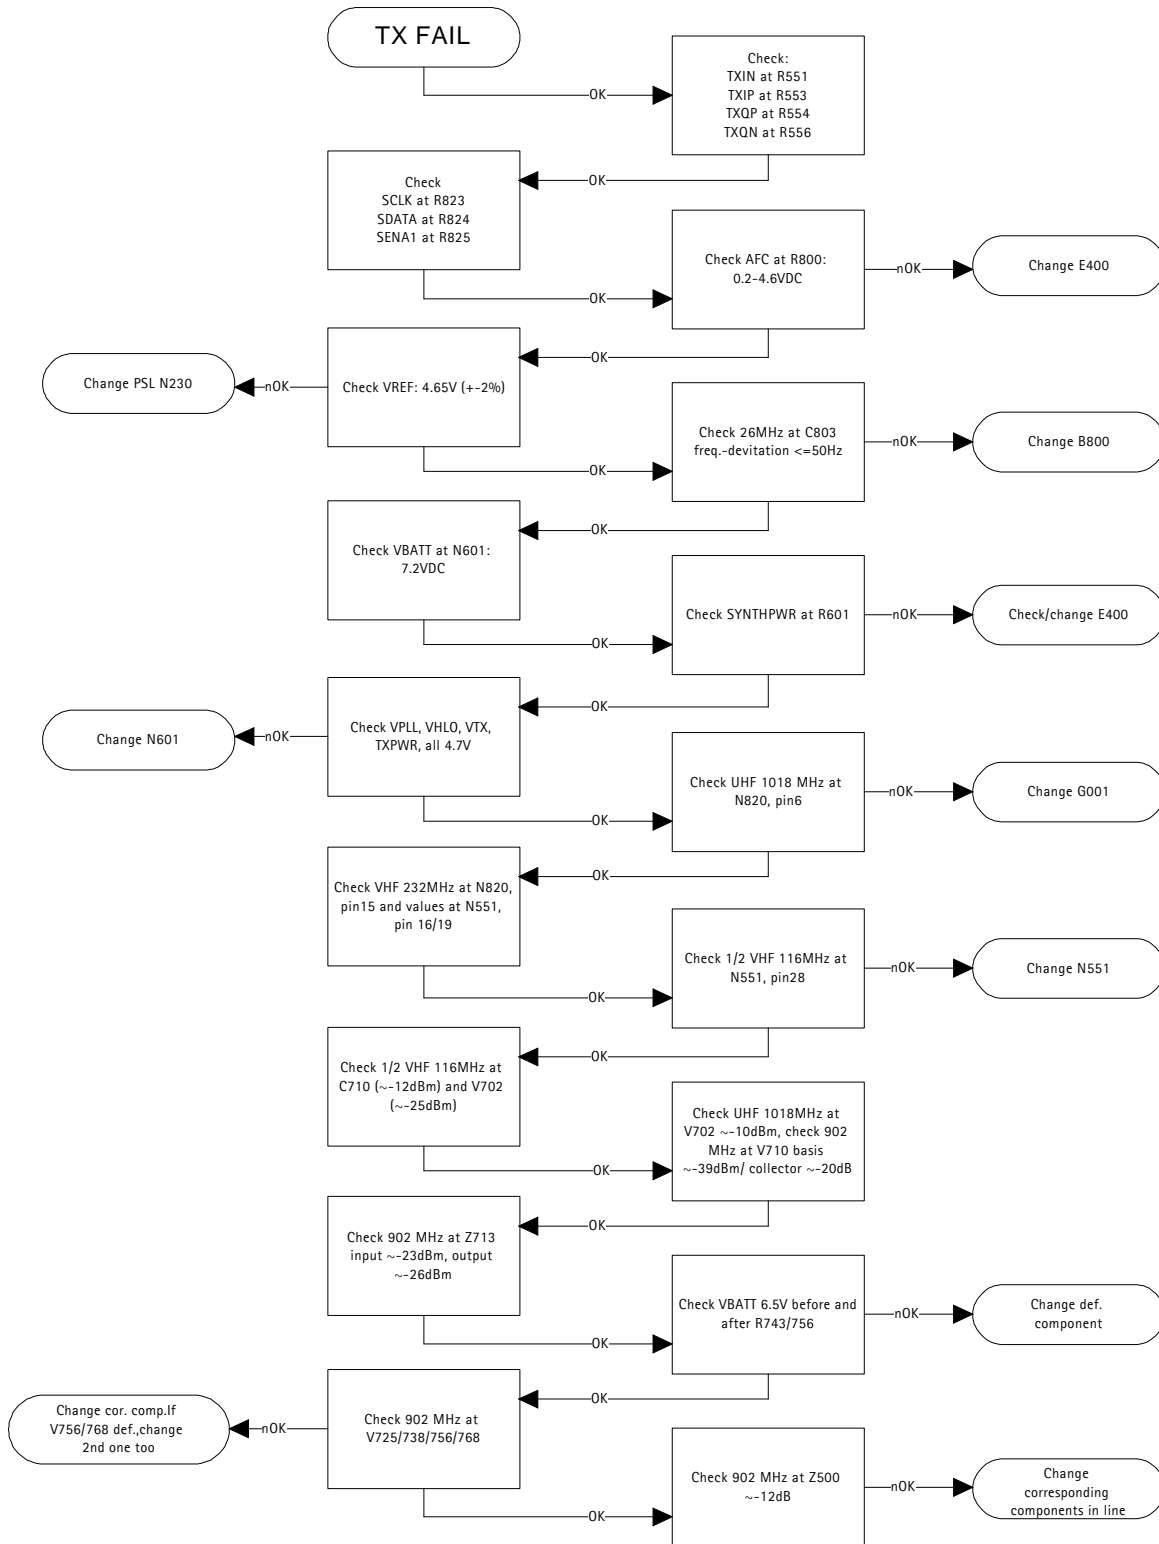
RAE-1

LOW OR NO TX POWER (RAE-1)

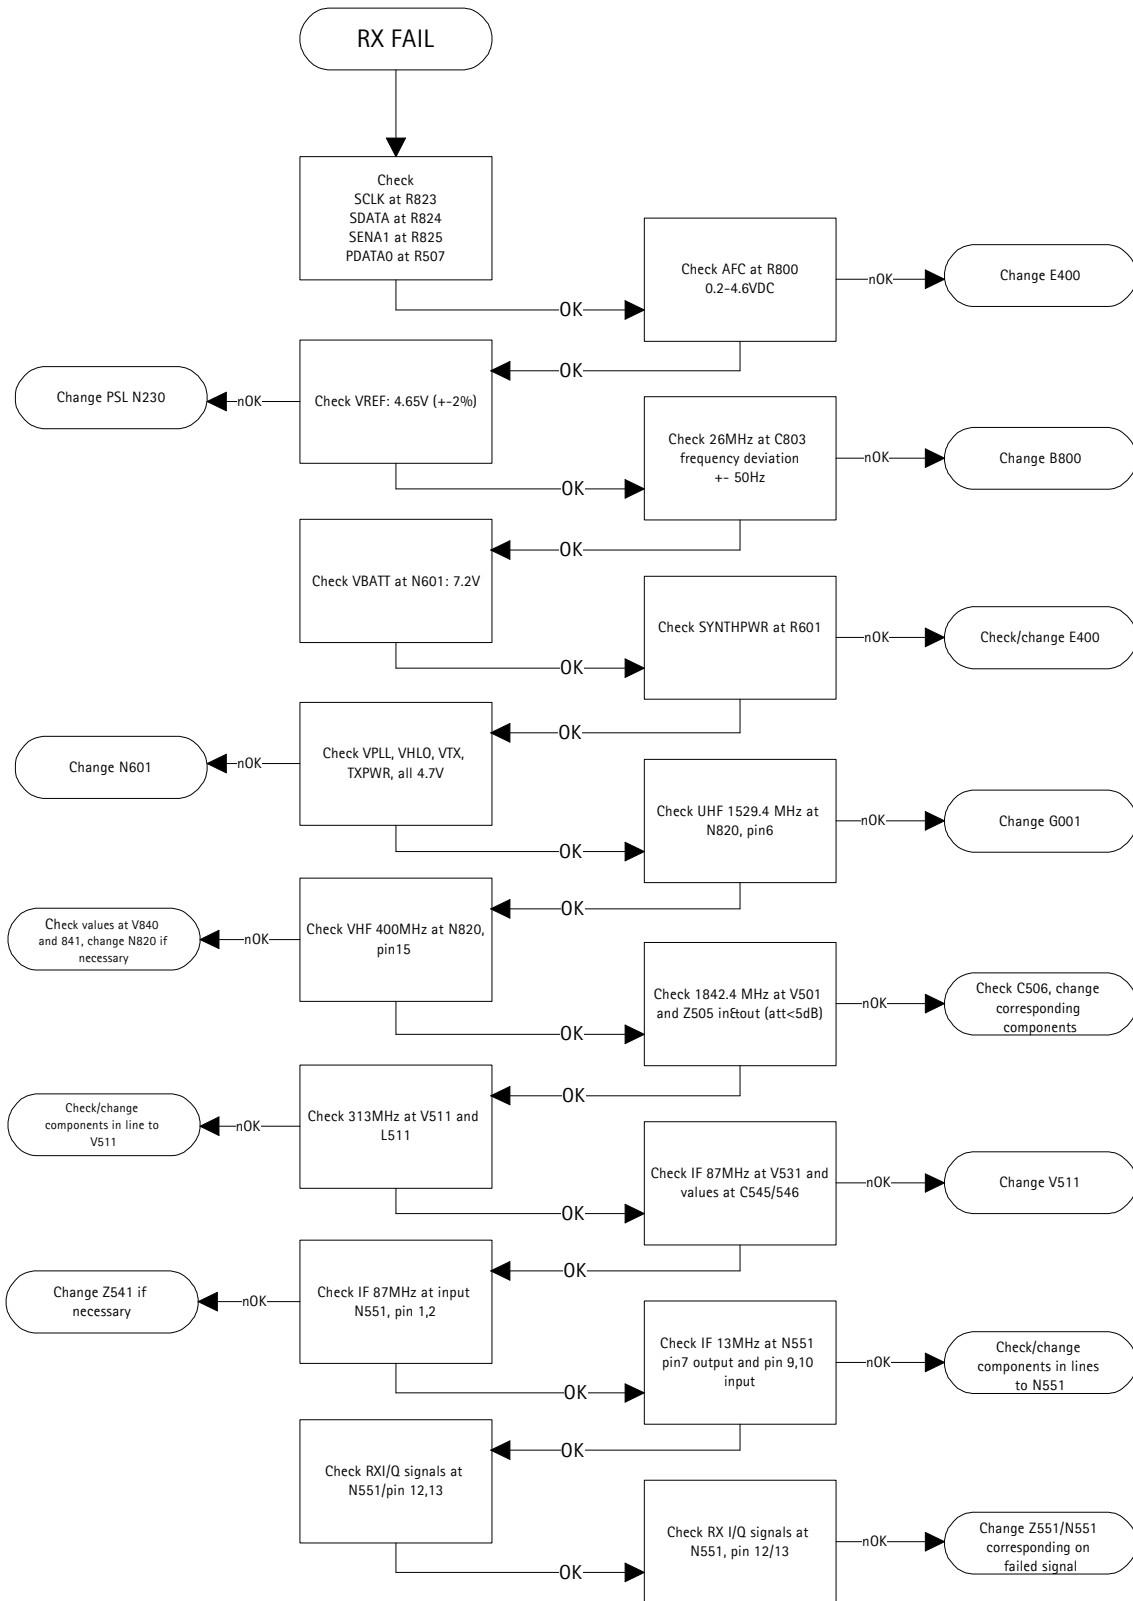
RAK-1

POOR OR NO SERVICE (RAK-1)

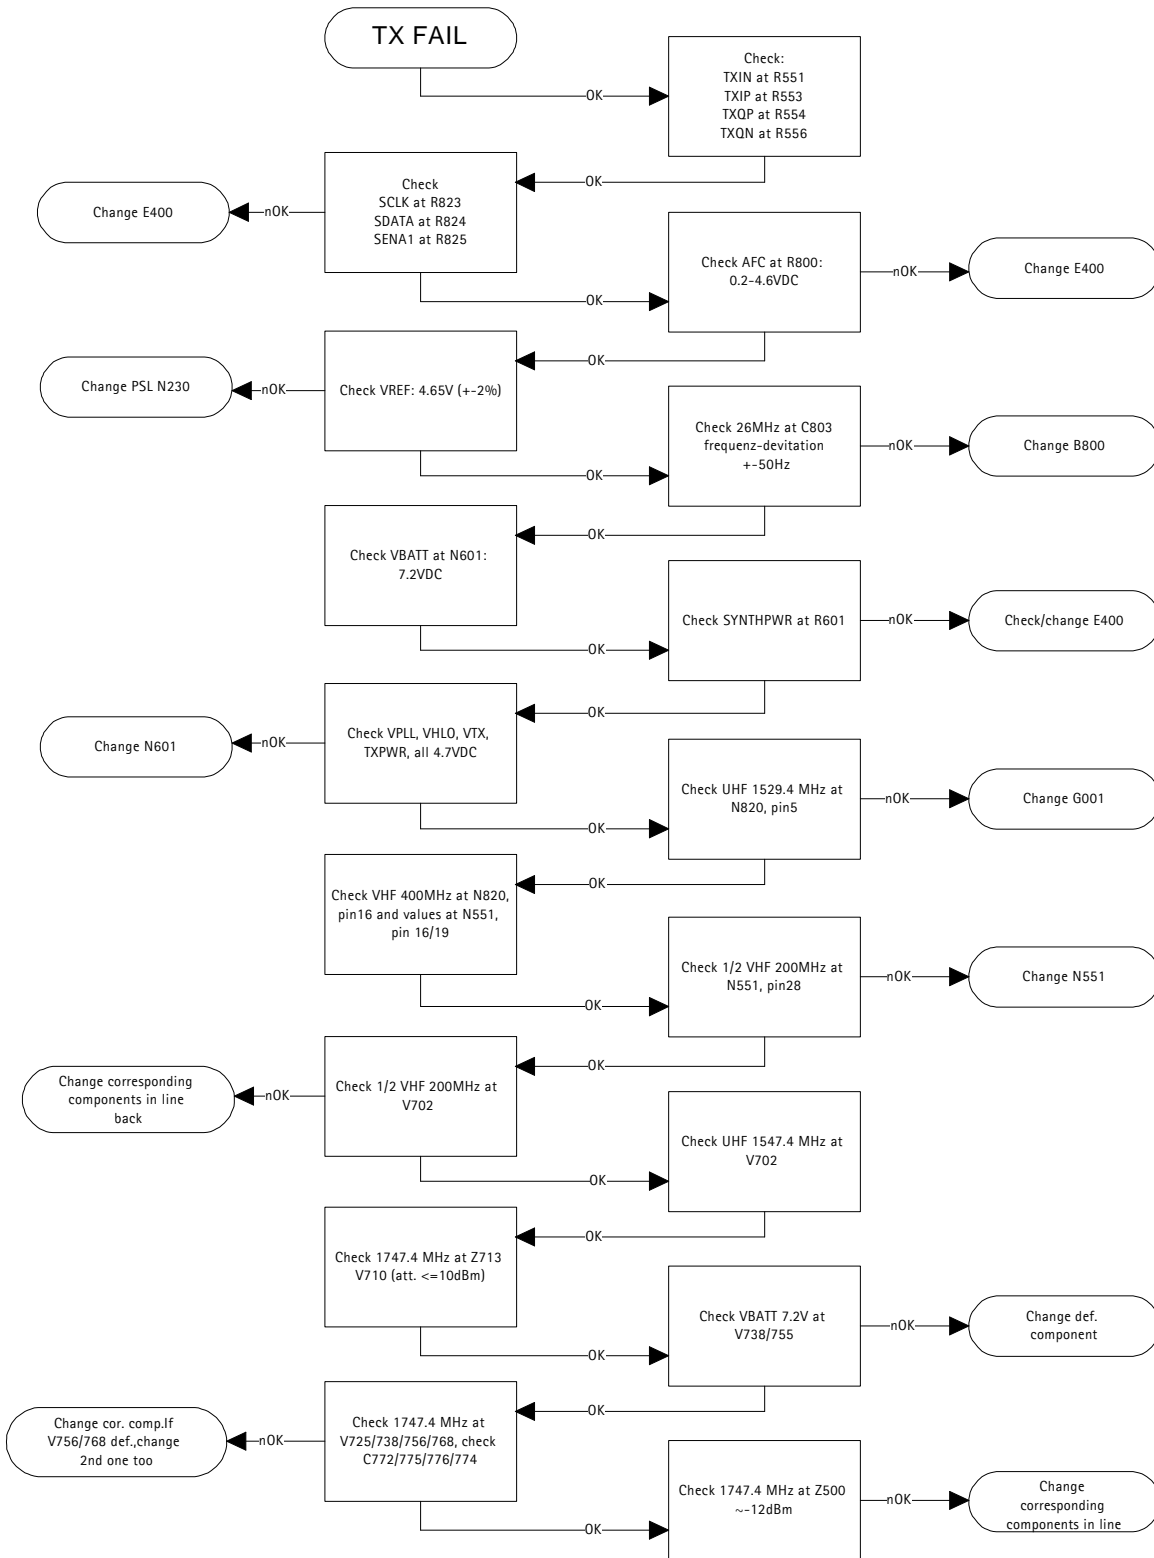
RAK-1

LOW OR NO TX POWER (RAK-1)

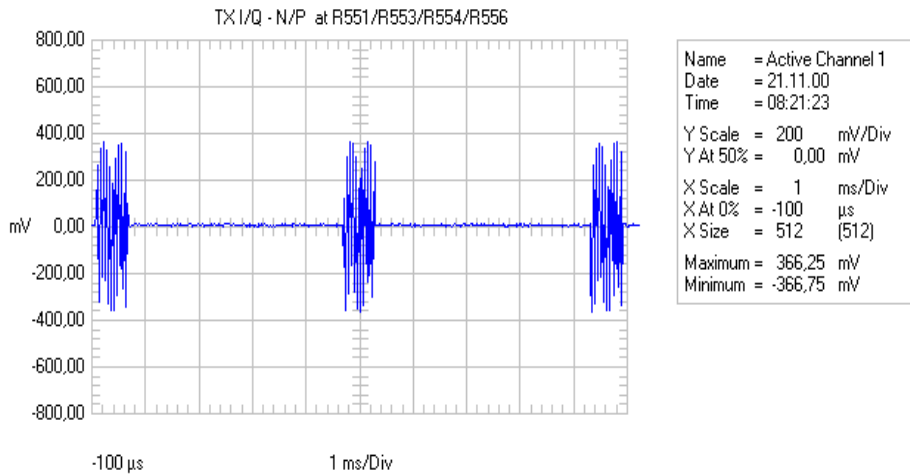
TXIN	:	400mVpp squarewave at R551
TXIP	:	400mVpp squarewave at R553
TXQP	:	400mVpp squarewave at R554
TXQN	:	400mVpp squarewave at R556

- Check soldering / change N551 if necessary
- Check soldering / change E400 if necessary
