Repairhints

Communicator 9000/9000i RAE/K-1/4

The purpose of this document is to provide some further service information for NOKIA Communicator 9000/I. It contains a lot of collected tips and hints to find failures and repair solutions easily.

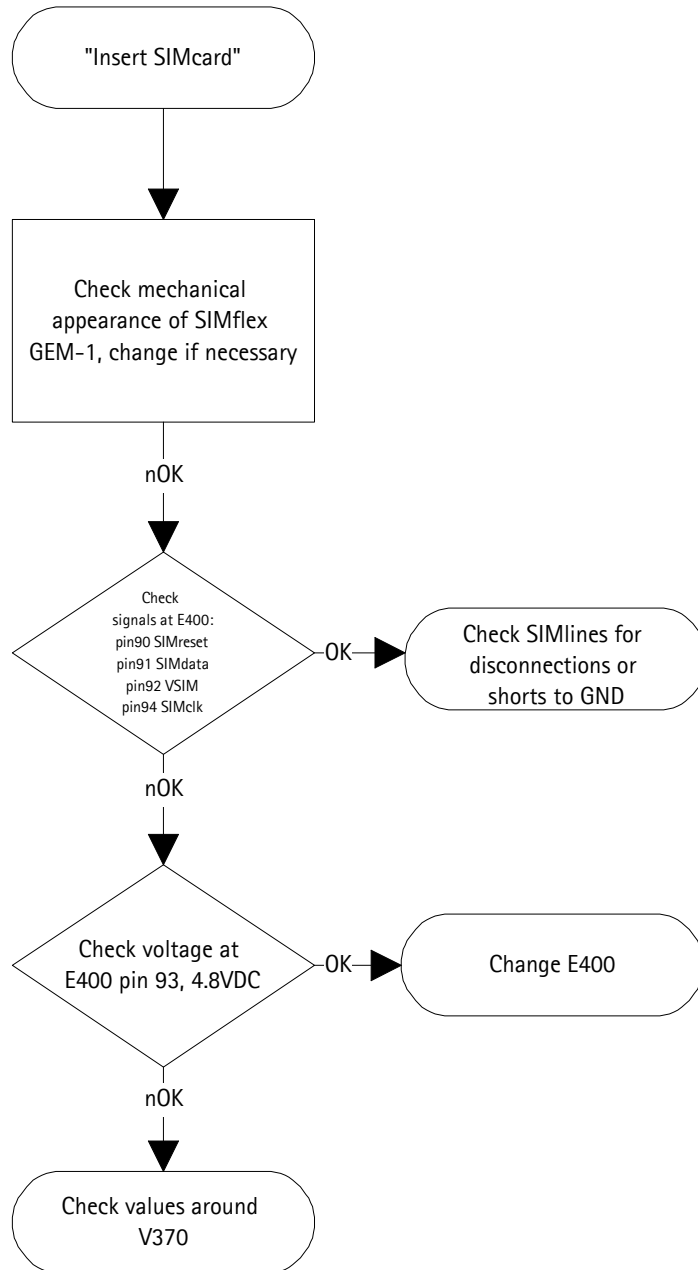
SIMCARD FAULTS

VSIM after switching on the phone without SIMcard. E 400 pulses up VSIM four times to an amplitude of 5 Volt.

If the phone is switched on with SIMcard Vsim keeps on 5 Volt expected that SIMcard is not dirty or damaged.
